Rock mass defect controlled deep-seated landslides in Tertiary soft rock terrain: Implications for landscape evolution

A thesis submitted in partial fulfilment
of the requirements for the degree
of
Master of Science in Engineering Geology

Joshu Mountjoy

Department of Geological Sciences
University of Canterbury
2005

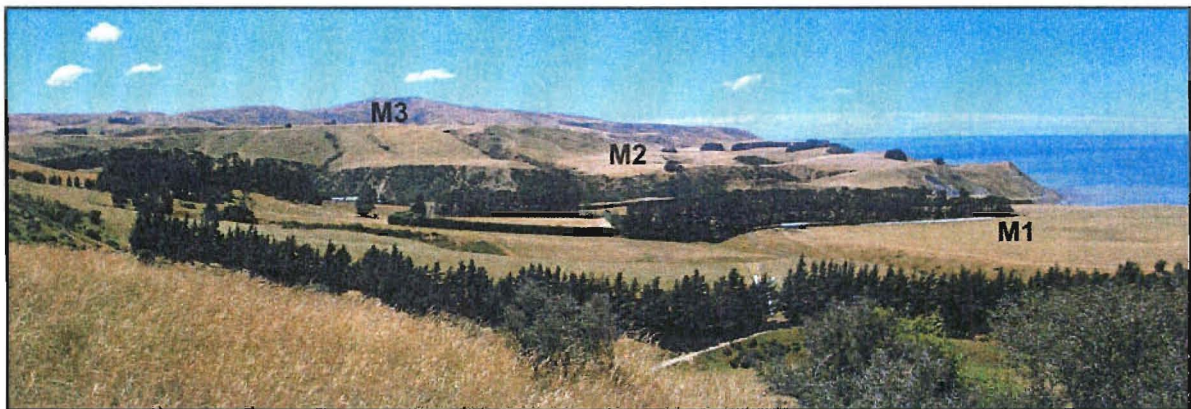
Figure 2.8: Looking north from adjacent to lower Kate Valley towards uplifted marine platforms. The marine platform surface chronology is shown and age control is discussed in text (note surface M4 not visible in this photo).

Ongoing tectonic activity in coastal North Canterbury is reflected by uplifted and sometimes tilted marine platforms (Figure 2.8, and also shown in Figure 2.6 as marine terrace deposits) and deeply incised stream networks. The Kate Stream catchment is representative of the many small catchments developing in the Tertiary soft rock sequences of the North Canterbury fold and fault belt, and the development of these landscapes can be considered in terms of tectonic and climatic forcing (as discussed in Chapter 1).

Tectonic and climatic forcing have a dominant control on geomorphic development of coastal catchments in North Canterbury. Variation in regional base level, driven by long-term tectonic and climatic forcing in the form of ongoing tectonic uplift and orbitally forced glacial and interglacial cycles, directly influences rates and patterns of stream incision. The marine platforms around the study area (Figure 2.8) have been assigned ages

of $M1 \approx 60$ kyr, $M2 \approx 80$ kyr, $M3 \approx 105$ kyr and $M4 \approx 125$ kyr (Yousif, 1987) and provide uplift rates of $1.36 - 2.16$ mm/yr (Nicol et al., 1994), with a maximum uplift rate for the coastal ranges calculated to be 2.68 ± 0.2 mm/yr. Folding and faulting of Tertiary cover sequences in this area is not thought to have commenced until the early Pleistocene (Nicol et al., 1994), driven by an average absolute shortening rate of $0.8 \pm 0.4\%/100$ kyr in the coastal ranges. In Kate Valley, as in other catchments in the area, asymmetric folding has a controlling influence on topography with the Teviotdale Syncline – Kate Anticline pair being broadly coincident with Kate Valley and the seaward ridge, and Kate Stream in the mid-upper catchment flowing along the axis of the Teviotdale Syncline. Most valley and range systems in the region are aligned NE – SW, reflecting the structural grain of the North Canterbury Fold and Fault Belt.

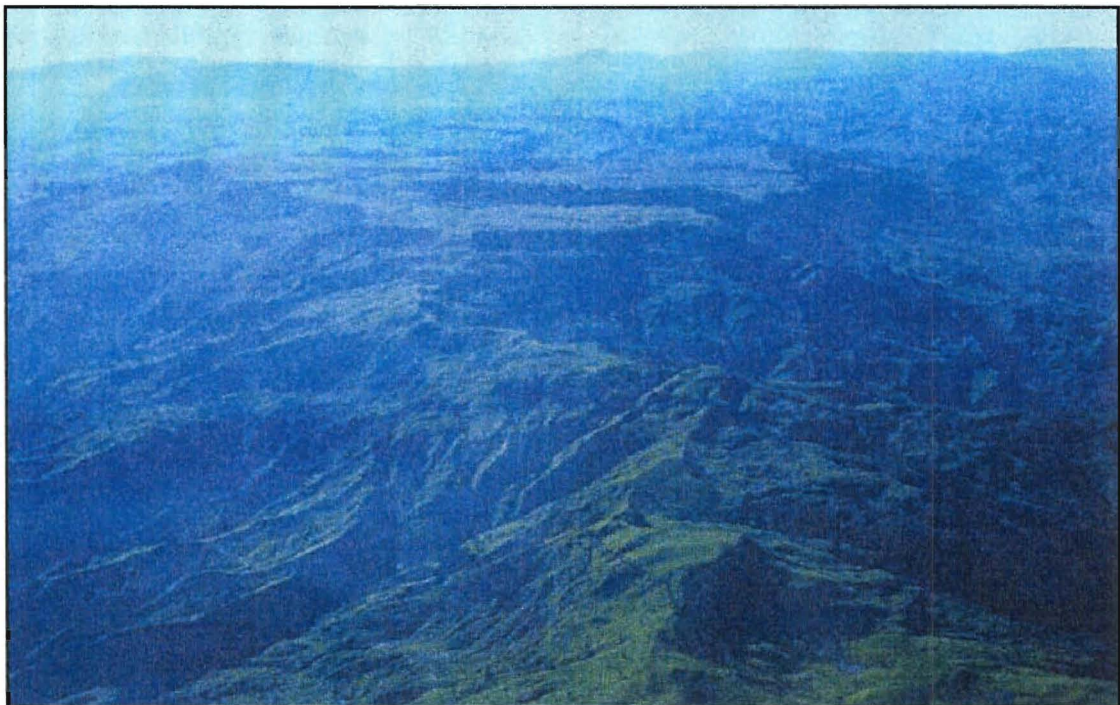
Figure 2.10: Oblique aerial photograph of the Maraetotara Plateau and adjacent catchments. The main catchments of interest to this study are visible in the foreground with the southeastern Maraetotara Plateau forming the flat area in the middle distance. Photograph taken looking north from approximately 6137000N 2844500E (NZMG 260 series topographic map sheet V22). Photograph courtesy of J. Pettinga.

The Hawke's Bay study site is located on the highest coastal range in Southern Hawke's Bay, and can be broadly described as an uplifted plateau flanked by a dissected landscape of deeply incised catchments (Figure 2.10). The stream catchments under consideration flank the southeastern margin of the Maraetotara Plateau (Ponui, Makara and Te Apiti streams in Figure 2.12) and these are considered to be representative of a greater population of catchments in which lithologically controlled deep-seated landslides are widespread and have a significant influence on landscape development. The geomorphic style of the landscape can again be considered in terms of tectonic and climatic forcing factors (discussed in Section 1.3).

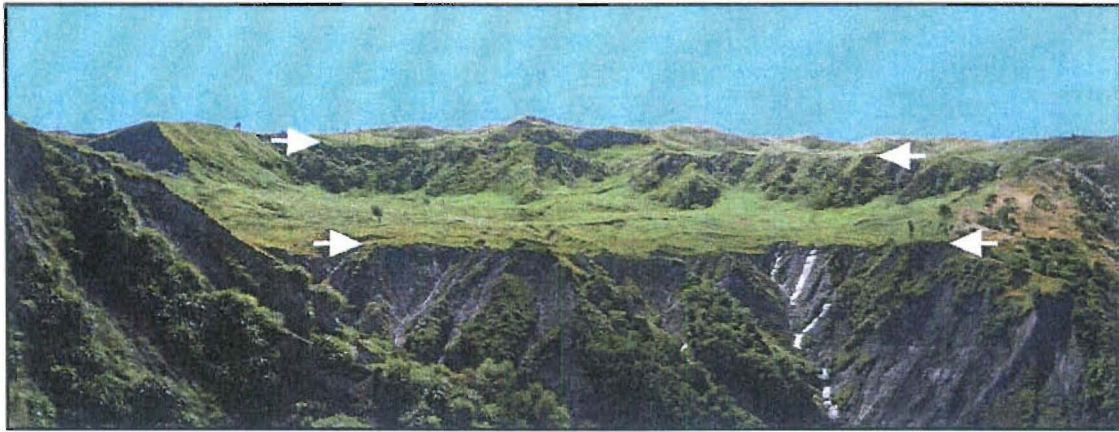
Figure 3.11: View of the Amphitheatre Landslide at the head of the Ponui catchment. The two near-horizontal, planar failure surfaces of the landslide complex are indicated with arrows and these are mantled by a layer of actively moving landslide debris. Photograph taken looking north east from 6137750N 2843500E (NZMG 260 series map sheet V22).

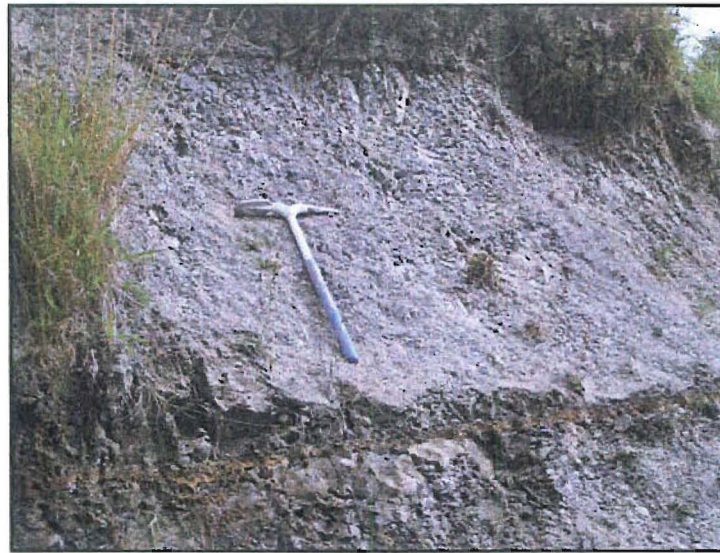
Figure 3.15: Tuff layer initially inferred to be controlling the failure surface of the Amphitheatre Landslide. The tuff is the horizontal brown layer below the 0.63 m long geopick. Location of exposure indicated as Exposure locality “A” in Figure 3.12.

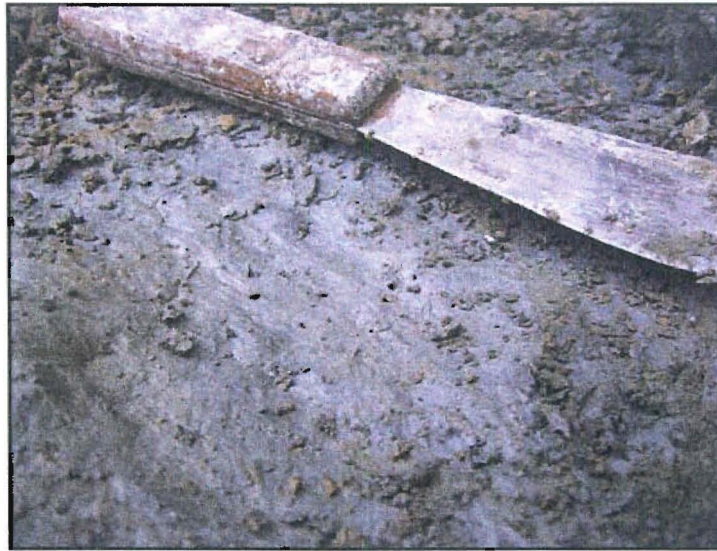
Figure 3.17: Surface polishing indicating shear displacement within the tuff layer stratigraphically below the Amphitheatre Landslide complex. Photograph taken in excavation of critical stratigraphic horizon at right of Figure 3.12.

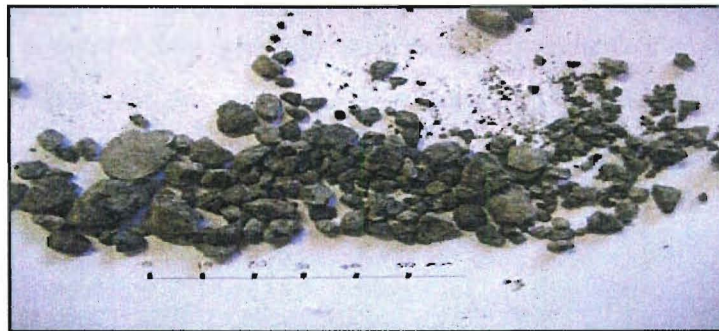
Figure 3.19: Mudstone clasts removed from Makara Formation tuff prior to ring shear testing.

The critical shear strength for an in-filled defect, where either clasts are matrix supported or defect asperities do not come into contact, is that mobilised in the gouge or matrix (Hoek, 1998). Although the tuffaceous layers in the Makara Formation contain some mudstone clasts, these are supported by the tuffaceous matrix and it is this material which will define the shear strength relevant to a deep-seated slope failure utilizing this horizon as a failure surface. Sample preparation for ring shear testing requires that material fragments > 2.0 mm are removed (British Standards Institution, 1990) and mudstone clasts > 2.0 mm were removed by hand (clasts shown in Figure 3.19).

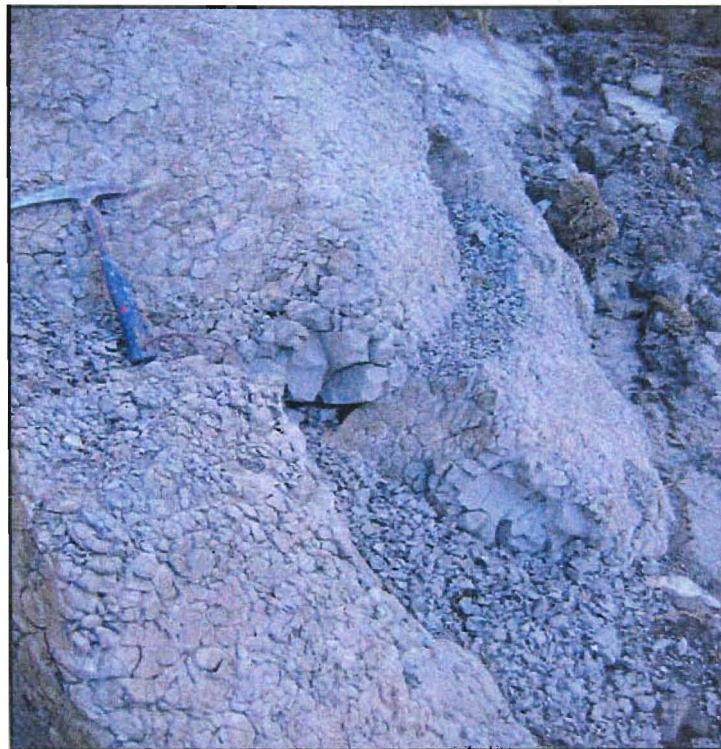
Figure 3.21: Field degradation (slaking) of intact Makara Formation mudstone near the head scarp of the Amphitheatre Landslide. Outcrop exposure located at 6138200N 2843950E (NZMG 260 series map sheet V22).

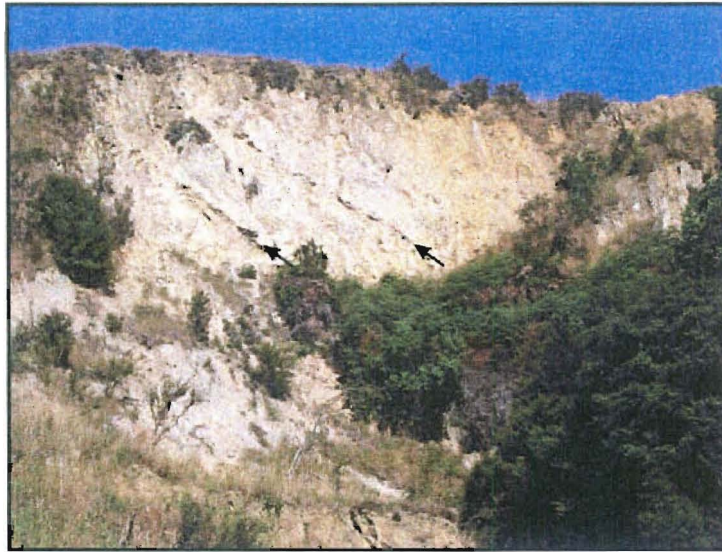
Figure 4.2: Apparent co-failure impact thrust fault development inferred to be the result of block slide impact into debris. Exposure locality “C” in Figure 3.1.

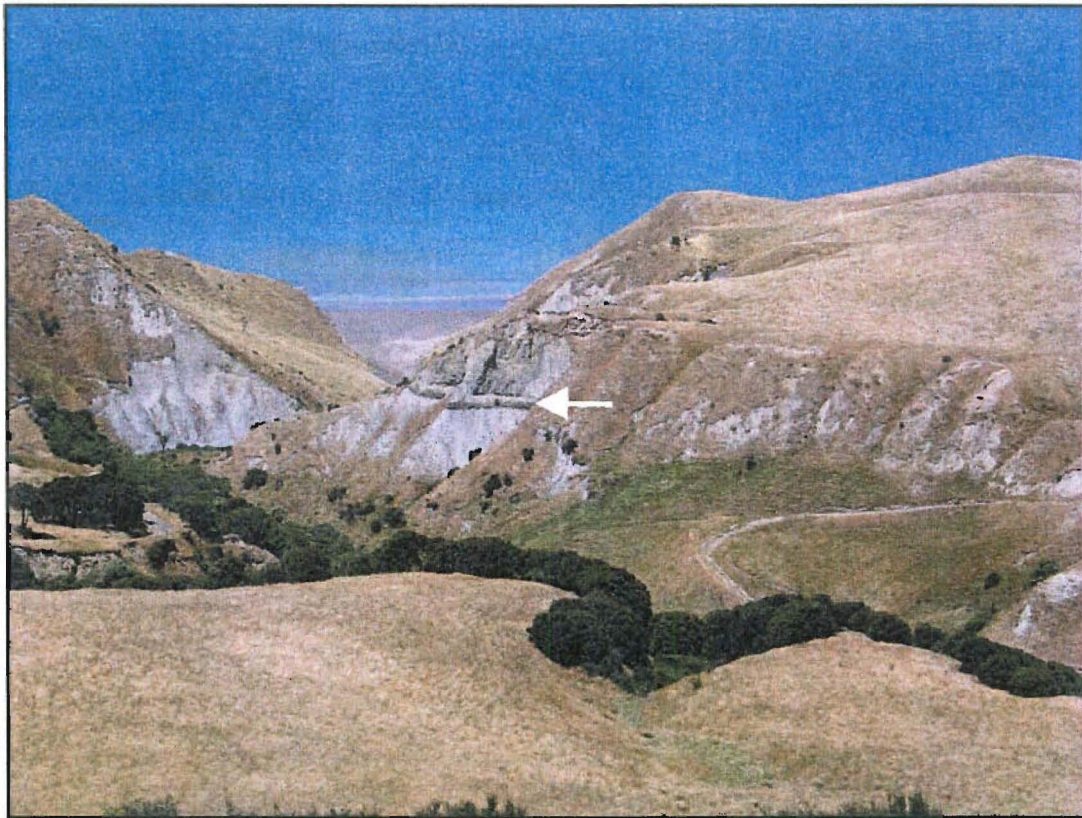
Figure 4.4: Unconsolidated sand bed acting as a seepage path within the Tokama Siltstone (dark layer indicated with arrow). Location of exposure shown in Figure 3.1 xx needs grid reference.

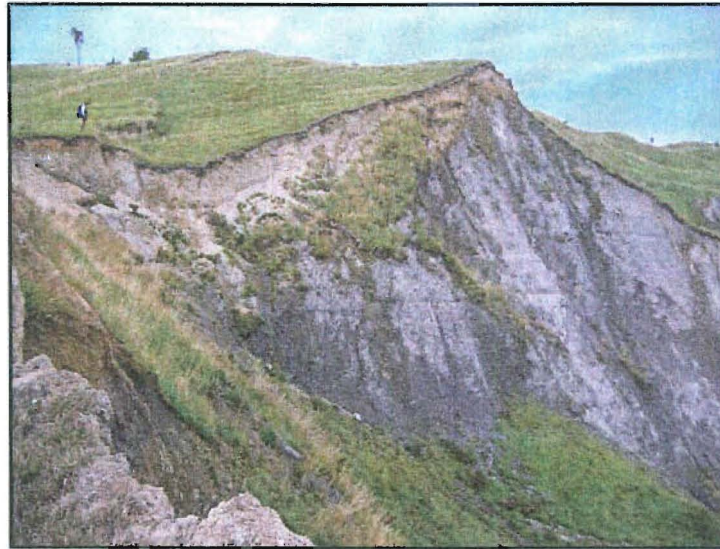
Figure 4.8: Slightly displaced block of intact Makara Formation mudstone on the head scarp of the lower level of the Amphitheatre Landslide, note the tension crack which defines the extent of the top surface of the block next to person for scale. The location of the block is indicated in Figure 4.6.

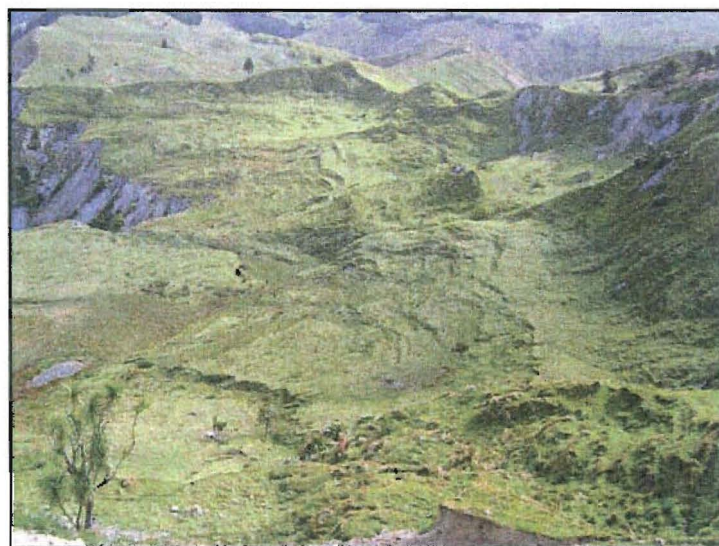
Figure 4.9: Lower level of the Amphitheatre Landslide with arcuate tension cracks reflecting the actively creeping debris on the almost exhumed basal failure surface (movement right to left). The mound of debris at centre right of the photo relates to the degradation of a block recently detached from the head scarp. Photograph taken looking south west from 6138200N 2843950E (NZMG 260 series map sheet V22).

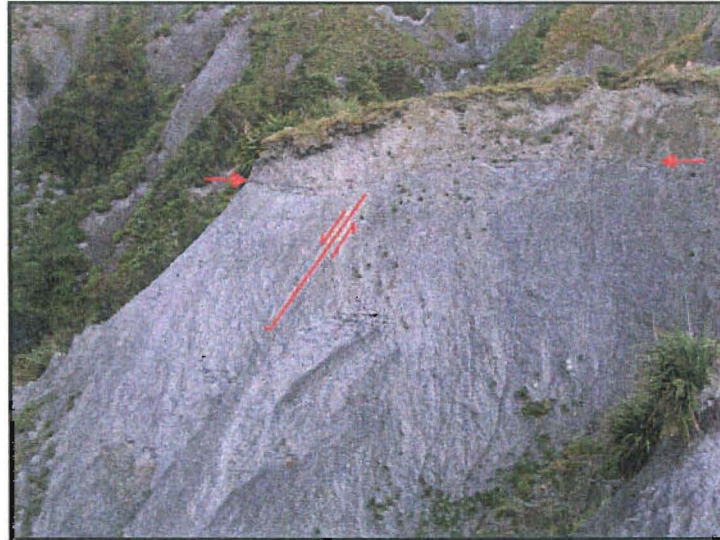
Figure 4.11: Slope parallel spur failure in the Ponui catchment involving the Amphitheatre Landslide basal shear surface, note the displaced failure surface contact with topsoil (arrowed). Photograph taken looking west from 6137950N 2843800E (NZMG 260 series map sheet V22).

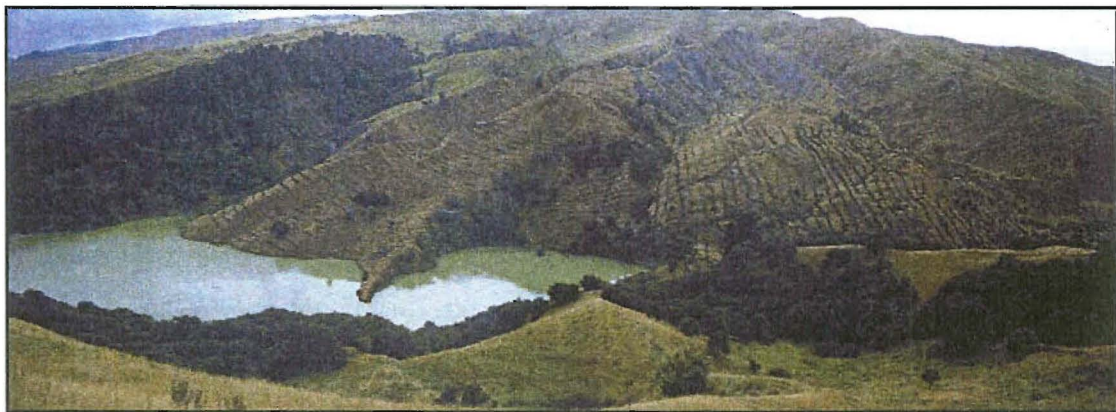
Figure 6.2: Ponui Landslide after failure showing the landslide dam formed by the slide debris (right of photo with pine tree plantation running upslope), bedding dips right to left at between 12 and 36° (Pettinga, 1980). The lateral scarp from another wedge failure is evident at the left of the photo covered in native forest. This scarp is just visible at the right hand edge of the photograph in Figure 6.1. Photograph courtesy of J. Pettinga.
